MASTER PLAN FOR BROOKDALE CEMETERY Dedham, Massachusetts

Town of Dedham
Department of Public Works

January 2002

VOLLMER ASSOCIATES_{LLP}
ENGINEERS•LANDSCAPE ARCHITECTS•PLANNERS•SURVEYORS

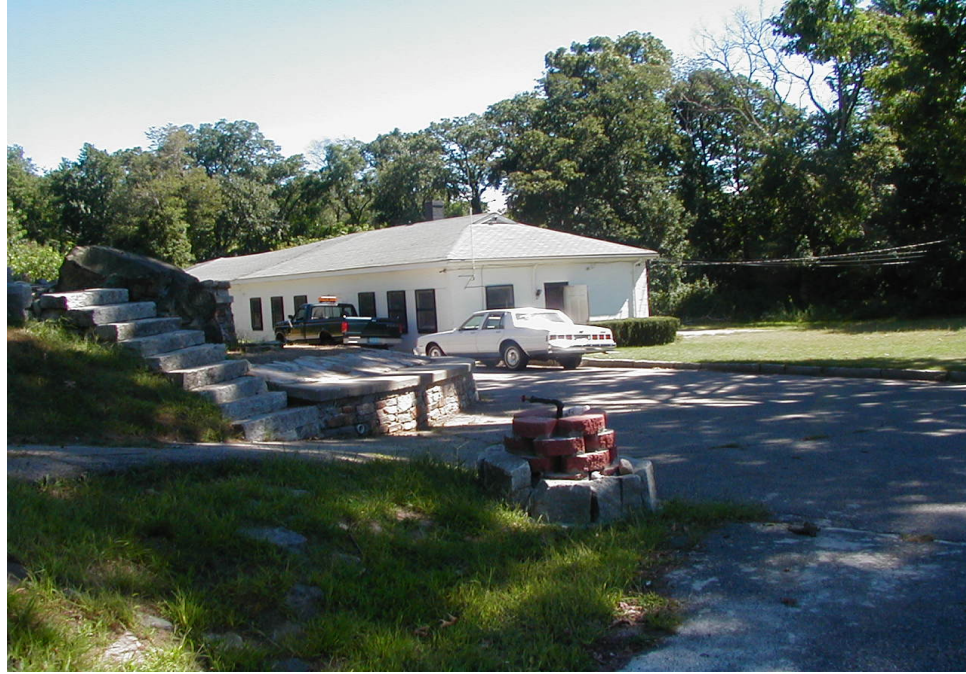
FIGURE 2 – VIEW OF OFFICE AREA

As evidenced by the summary assesment in Table 2-1, the building is generally in poor condition and in need of major improvements. The building, situated at the base of a hill, is plagued by water leaking onto the floor during severe rain events. The slab on grade floor further exacerbates the problem, allowing water to flow through the building. A raised platform has been constructed within the office area to minimize the water damage. Water leakage has caused the formation of mold and mildew throughout the building. According to cemetery personnel, a French drain was installed on the exterior in an attempt to mitigate the leakage, apparently without success.

Therefore, we suggest that the Town have a new Office/Maintenance Building constructed. Our recommendations for a new Office/Maintenance Building are discussed in greater detail in Section 3.0 of this report.

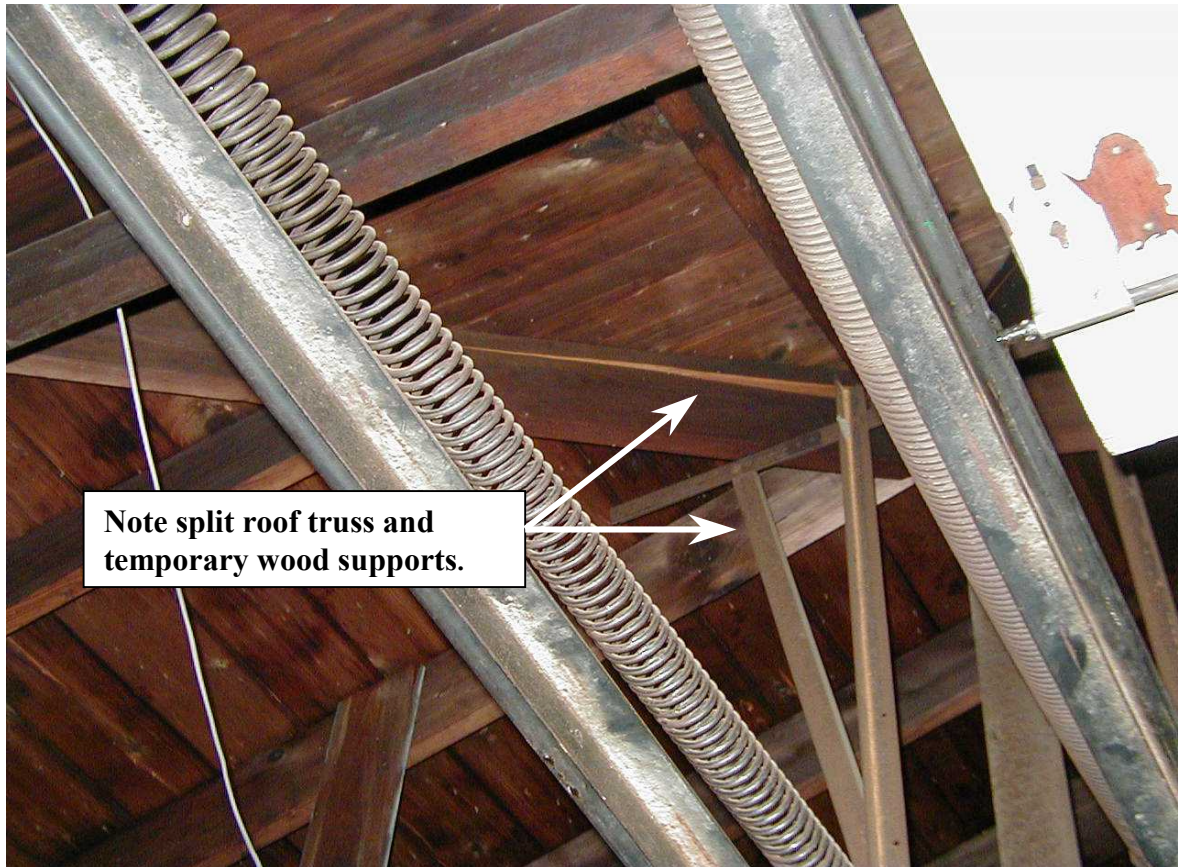
FIGURE 4 – DAMAGED ROOF TRUSS

Several roof trusses have been damaged in one of the garage stalls and are being supported by temporary wood framing (see Figure 4 below).

• Seal crack and replace or reinforce broken joists	\$ 5,000
• Replace entire wood framed garage.	\$30,000
• Construct handicap accessible bathrooms.	\$25,000
Subtotal	\$140,000
<u>Mechanical/HVAC Improvements:</u>

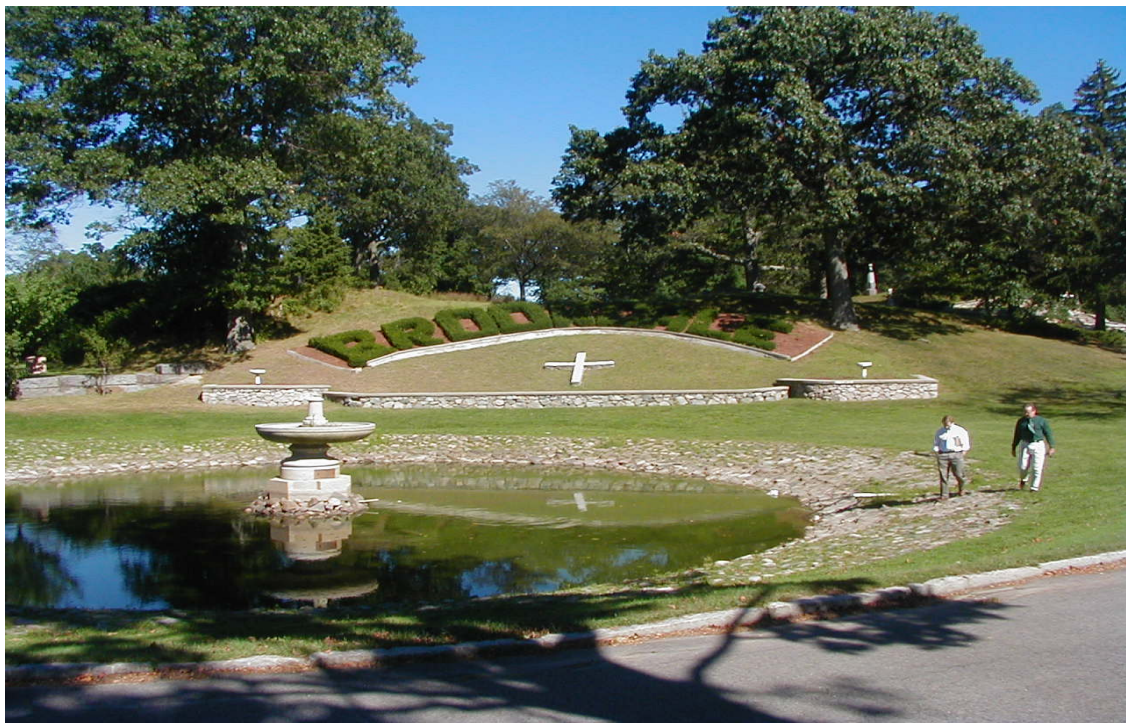
FIGURE 5 – EXISTING EBENEZER T. PAUL FOUNTAIN

A fountain is located to the west of the main entrance. (see Figure 5 below). On the hillside behind the fountain, the name “Brookdale” is spelled out with yew hedges. There is also a Christian cross and some low stone walls at the base of the hill. The fountain was a gift to the Town erected in memory of Ebenezer T. Paul by his wife Marietta Paul. The fountain is not currently operating because of a pinched water supply line. The line was pinched by the weight of the fountain, which fell on it when the soil beneath the fountain and the fountain shifted. The pond in which the fountain is located has an earth bottom that is difficult to clean and maintain. The pond is cloudy due to

organics, algae, and other particulates suspended in the water. The cloudy water draws attention away from the aesthetic aspects of the fountain.

The Ebenezer T. Paul Fountain and the landscaped backdrop are the focal point of the cemetery. As such, Vollmer recommends that the fountain be restored to working condition, and that the pond be lined to retain water. This will involve a new foundation support for the fountain, a new fountainhead, a Gunitite liner with low profile, architecturally aesthetic sidewalls, a new water line, a new drain, and a water recirculation/skimmer system, as shown in Figure 8.

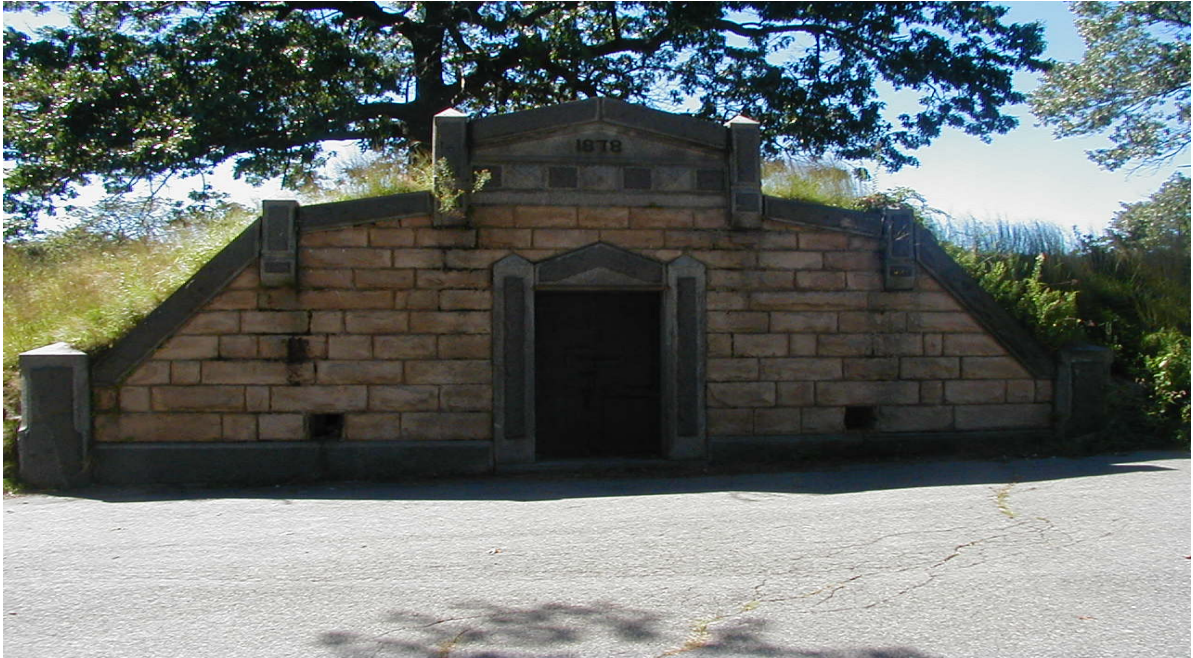
FIGURE 12 – EXISTING TOMB FACADE

The existing tomb has an attractive pink granite block façade (see Figure 12) that has become weathered and tarnished. Vollmer recommends that the granite blocks be cleaned and that loose mortar joints be re-pointed. If Town and the Cemetery Advisory Committee desire not to incorporate the tomb into the memorial garden then it should be removed and the granite blocks salvaged.
